DESIGN REVIEW BOARD
for
Dollar Slice Club
AWV2021-000017
NRA 2021-000023

REQUEST: Waiver to UDO Section 12-5.8.B.3.b, Standards and Building Design Considerations for Historic Properties, to allow exterior façade materials to be replaced and door positions moved on the primary entrance façade facing the pedestrian promenade on College Main.

Name of Project: NEW STOREFRONT GLASS SYSTEM TO REPLACE ROTTING WOOD SYSTEM

DOLLAR SLICE CLUB
104 COLLEGE MAIN, COLLEGE STATION, TX

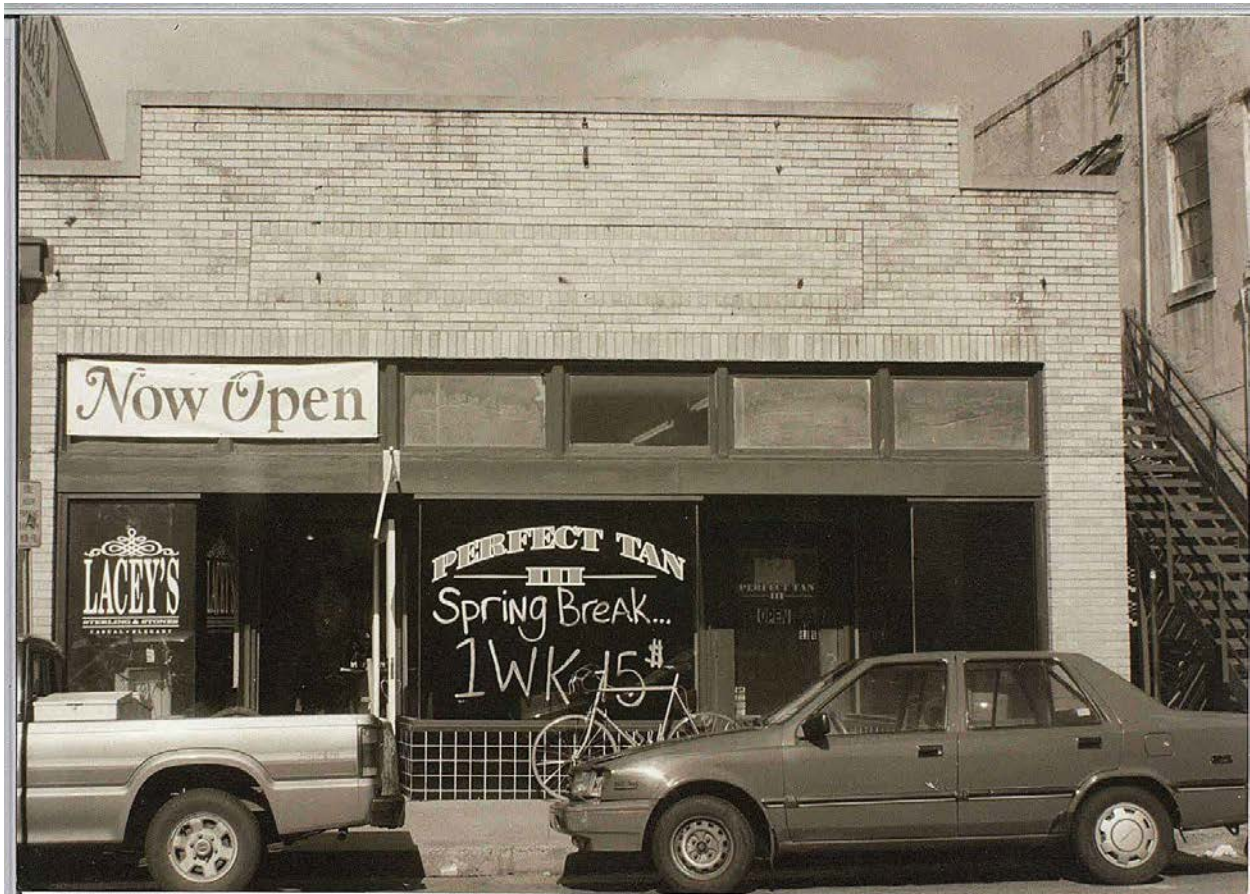
ITEM BACKGROUND: The building located at 104 College Main is currently occupied by Antonio's Pizza. Prior to this, the building was a dual tenant space, hence the two main entrances. With the conversion to Antonio's Pizza, the two-tenant building was remodeled for one, but the entry bays were left intact.

ITEM SUMMARY: The request is to allow for the renovation and redesign of the primary entrance façade that faces College Main. A new tenant, Dollar Slice Club, is looking to update the main façade of the building. The original wood framing system for the windows and doors has deteriorated and the applicant is requesting to replace it with more durable aluminum mullions that are powder coated the original green color. Also, due to building code regulations, increased interior occupancy loads require the two main entrances to be spaced apart at a greater distance to meet necessary egress requirements.

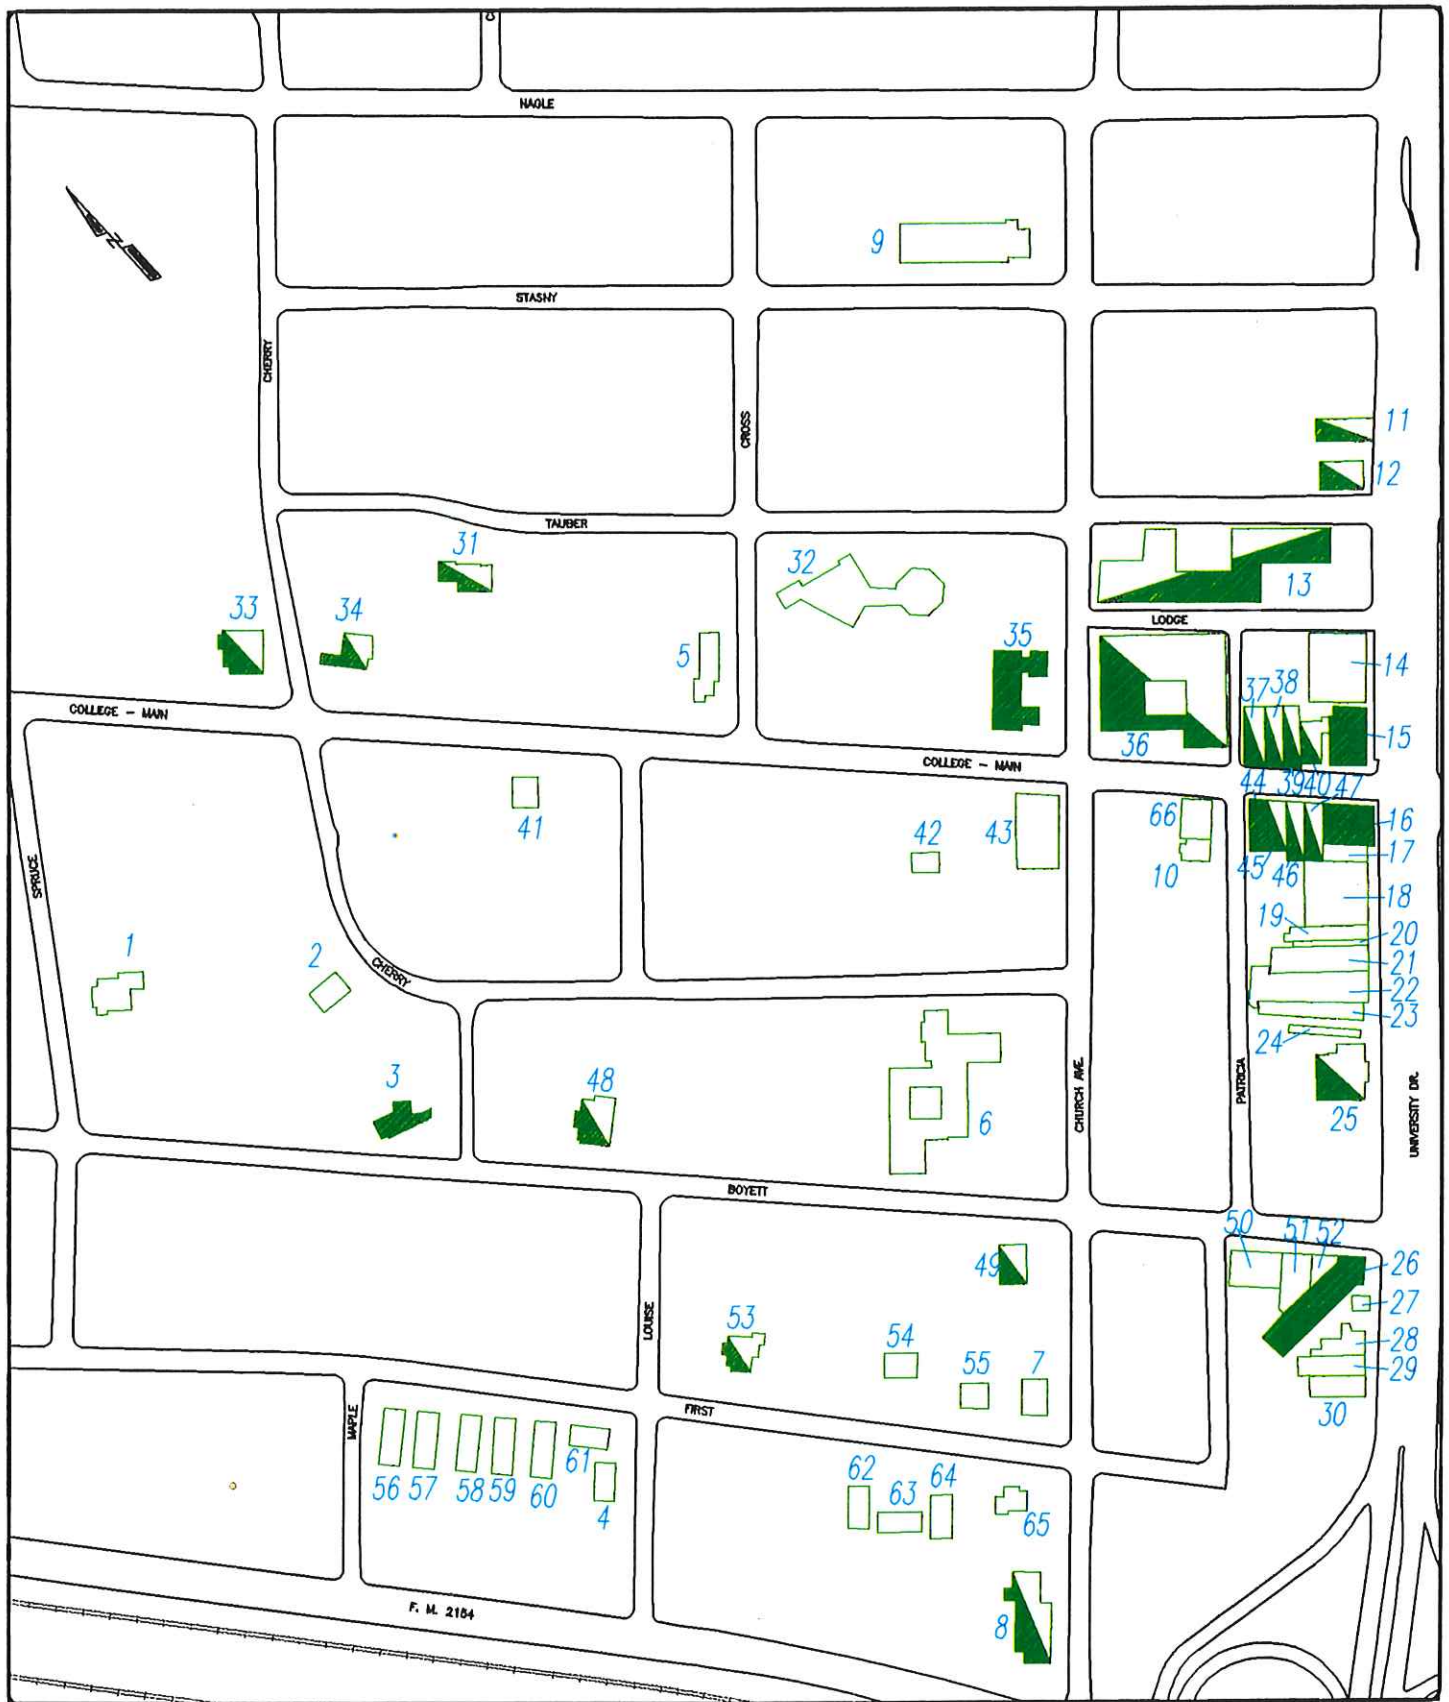
Survey Base Map

The next phase of fieldwork consisted of taking black and white photographs and color slides of each structure. The location and configuration of each building was plotted on a current GIS base map, which was generated from recent aerial photographs. Each structure was assigned a unique number, and the address, building type, approximate construction date, condition and preservation priority were compiled to form a master list, or inventory, included in this document as *Historic Resources Inventory*, Appendix 1. Initially, the primary elevations were taken of each surveyed structure and were documented on contact sheets (Rolls 1-2), and color slides. Subsequently, additional photodocumentation was taken of each structure with multiple views and architectural details of the medium and high preservation priority structures. These contact sheets and slides are kept in the Development Services Department of City Hall, located at 1101 Texas Avenue, College Station, Texas.
